FAILURE ANALYSIS OF A REACTOR POOL COOLING PUMP USING MODAL AND VIBRATION ANALYSIS

Thomas J. Hazelwood, Larry D. Phillips, and Blake W. Van Hoy

Oak Ridge National Laboratory

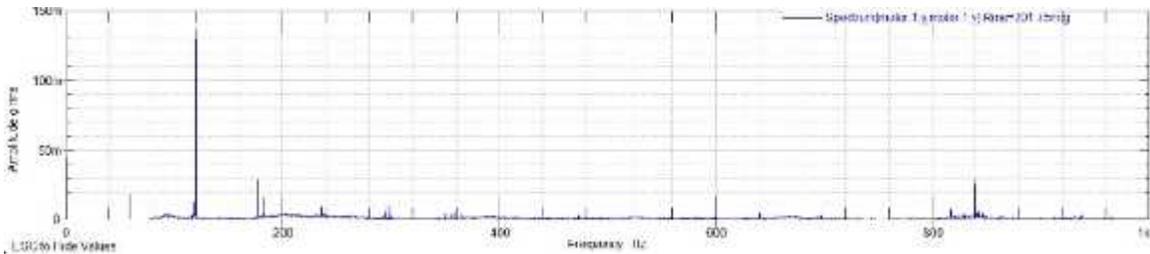
Figure 11: Steady State Outboard Motor Spectrum (Horizontal Radial)

Steady State Spectrum: The steady state spectrum data set consists of several minutes of time waveform data. The data was sectioned into blocks and each block was transformed into the frequency domain using the Fast Fourier Transform (FFT). Each FFT was then averaged into a single set of spectrum data. This process was repeated for each accelerometer. Significant and representative data will be displayed and discussed within this report. It is important to note that the run speed of the motor is 59.3 Hz. One and two times run speed (1x and 2x) peaks with harmonics show up in the motor's spectrum (See 'Figure 11" and 'Figure 12').

The 1x vibration is indicative of some shaft unbalance, but it is much lower than the 2x vibration which is indicative of shaft misalignment. Care needs to be taken analyzing the

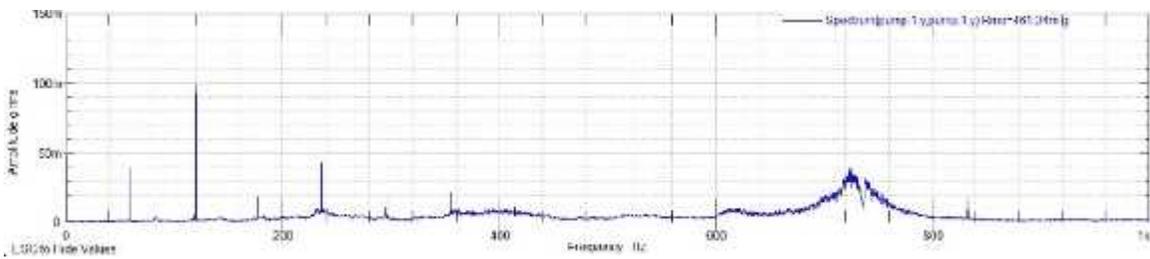
Figure 13: Steady State Inboard Pump Spectrum (Horizontal Radial)

One and two times run speed peaks with harmonics also show up in the pump's spectrum with the addition of broadband noise (See 'Figure 13' and 'Figure 14'). Also, note the twin peak in 'Figure 13' around 720 Hz, as this will be discussed in the Modal Impact section.

2x vibration in separating the two times run speed (118.6Hz) from two times the line frequency (120Hz). The bearing frequencies can be seen but are not significantly higher than the noise floor. This should be expected since they have recently been replaced. The broadband noise of the pump is indicative of hydrodynamic effects such as cavitation. Audio files of the pump and motor along with impulses within the time domain back up the impression of cavitation.

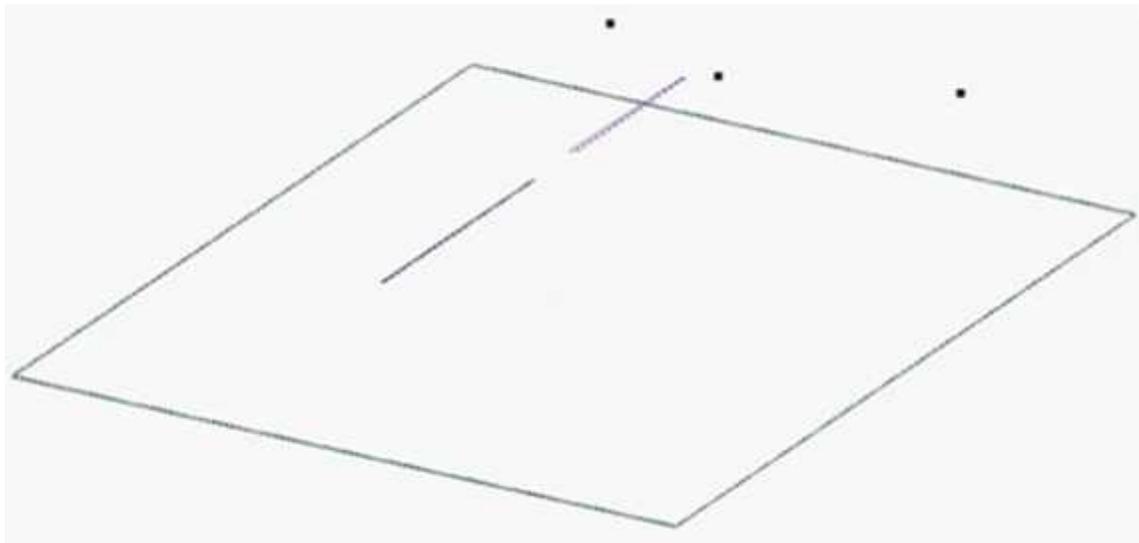
Figure 15: 1x Run Speed ODS

Steady State Operational Deflection Shape (ODS): Magnitude and phase data as a function of time from each accelerometer is combined with a simple representation of the system geometry to illustrate the operational deflection shape. The first ODS of interest, seen in 'Figure 15', utilizes the spectrum data from 1x the run speed. All deflections are scaled to the largest motion, which is 1 mil peak-peak of the discharge elbow. The dotted lines represent the non-deformed geometry. The shaft and the base have a relatively small deflection at this frequency.

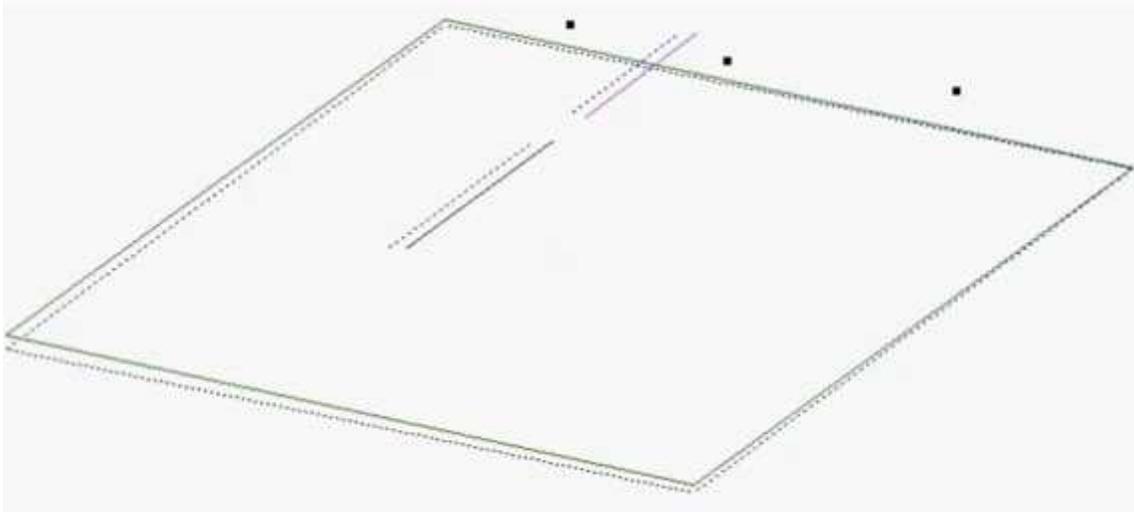
Figure 16: 2x Run Speed ODS

The Second ODS of interest, seen in 'Figure 16', utilizes the spectrum data from 2x the run speed. All deflections are scaled to the largest motion, which is 1 mil peak-peak of the suction mid pipe. There is high deflection of the shaft that also transfers to the base. A 2x run speed vibration of the shaft is often due to misalignment of the shaft, which the movement of the pipes can amplify.

Analysis Results Summary and Maintenance Suggestions: Overall, the pump is in a good conditional state as per ISO 10816 vibration standard. The 2x run speed vibrations seen in the steady state spectrum data and ODS data are indicative of misalignment in the shaft during operation. The motor's electrical grounding could be checked to rule out electrical fault causing a 120Hz peak and validating that it is in fact misalignment alone. The new bearing frequencies are present but not excessive, therefore, they have not worn out and were not damaged during installation. The high energy broadband noise in the pump spectrum is indicative of hydrodynamic issues such as cavitation. This could possibly be due to inadequate suction head pressure. It is suspected that this is due to piping layout. A piping engineer could verify this and suggest changes. If a piping teardown, redesign, and rebuild takes place, it is suggested that a new concrete and steel base be considered. The only modal interaction observed from the impact test is around 740 Hz at the pump and it is barely above noise level. This interaction could get worse if the cavitation were to get more severe. It is out of range of most other mechanical issues. Some cross talk from PU-9B can be measured on PU-9A when 9B is running, but it is less than twenty percent of the energy of operational 9A.

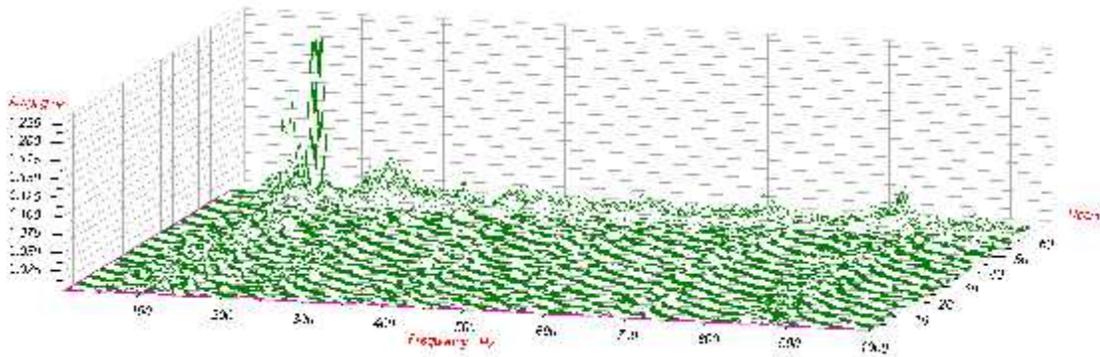
Figure 17: Motor Run Down Waterfall

Run Down Waterfall: The run down waterfall data set is taken in the exact same manner as the run up waterfall. The transient in this case is the pump going from operational speed to rest. ‘Figure 17’ is a representative measurement from the motor, plotted in reverse to aid in viewing. The lines in the front occurred last and the peaks occurred first. A 2x run speed peak is clear and some additional noise is present. The energy dissipates quickly, but some energy remains. This could be cross talk from the already running redundant pump.

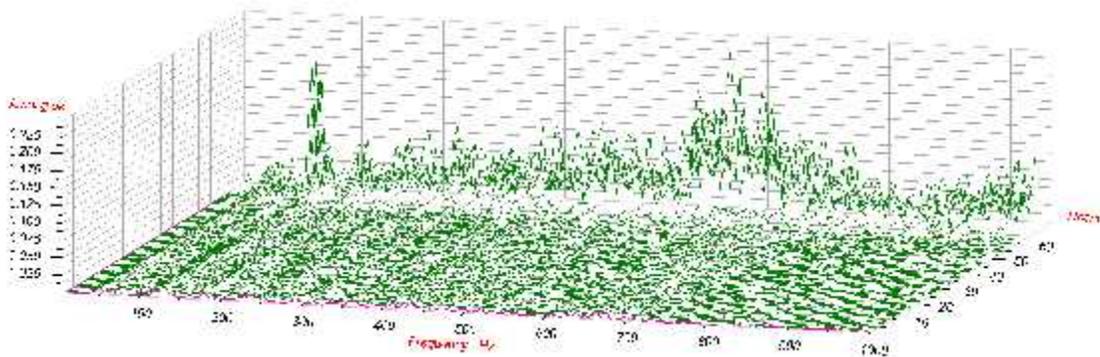
Figure 18: Pump Run Down Waterfall

“Figure 18’ is a representative measurement from the pump, also plotted in reverse. A 2x run speed peak is clear. Broadband noise is prevalent and a general peak around 700Hz is present. This peak will be discussed in the modal impact section.

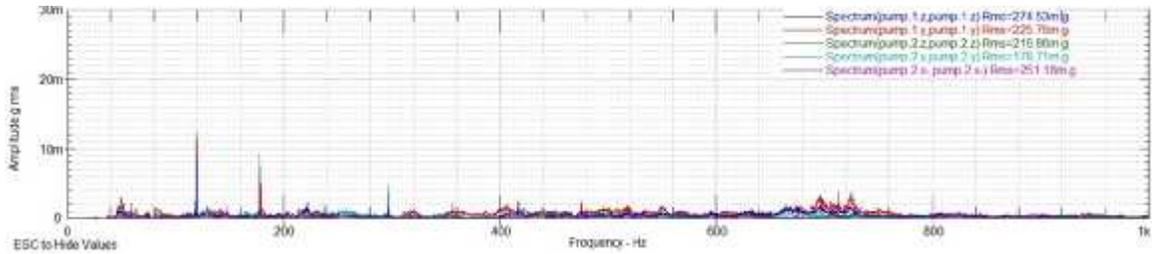
Figure 19: Stationary Pump Spectrum

Stationary Spectrum: The stationary spectrum data set was taken in a similar manner as the steady state spectrum except that the pump has been turned off and is at rest. The neighboring pump, PU-9B, is about ten feet away and has been turned on to continue the supply of cooling water. This data measures cross talk from PU-9B to the accelerometers on PU-9A. ‘Figure 19’ shows that the magnitude of the crosstalk present in the pump is about six percent of the pump during normal operation.

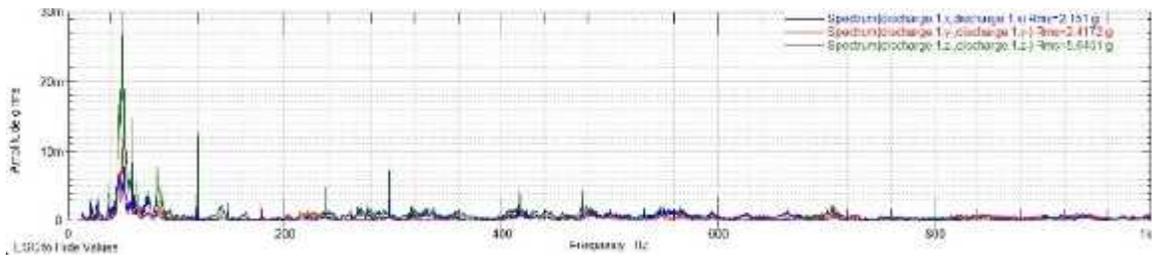
Figure 20: Stationary Discharge Spectrum

‘Figure 20’ shows that the magnitude of the crosstalk present in the piping is about twenty percent of piping during normal operation.

These results are expected, given the proximity of the two systems and that they share some common piping.

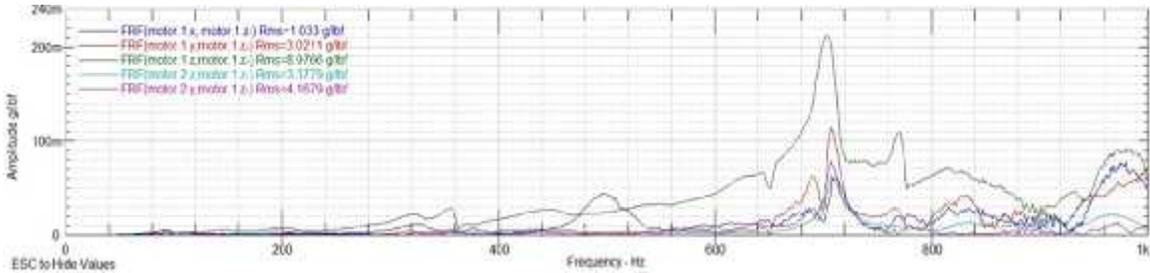
Figure 21: Motor FRF

Modal Impact: The modal impact data set is taken while the pump is at rest. Modal impact analysis was performed utilizing an additional channel of the data acquisition and a commercial modal impact hammer. Four averages were taken at each impact location and all twenty-six channels were acquired simultaneously. Using the hammer channel as the reference, a Frequency Response Function (FRF) was calculated for each channel. ‘Figure 21’ is a representative data set for the motor. The first modal resonance of the motor occurs at around 700Hz, but the mode does not appear to be excited during normal operation as seen in the steady state spectrum section of this report.

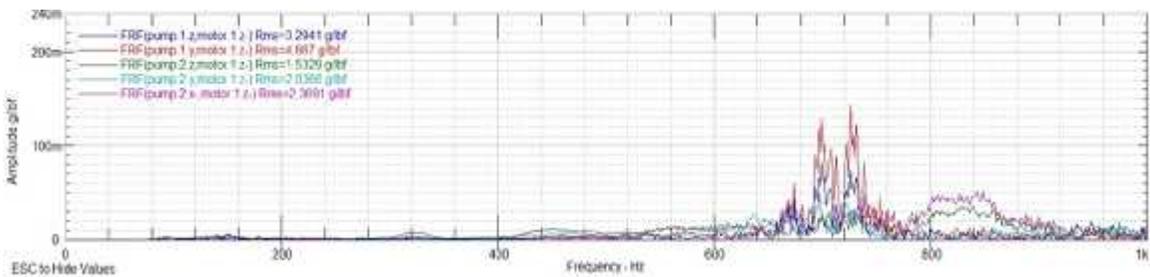
Figure 22: Pump FRF

‘Figure 22’ is a representative data set from the pump. The first modal resonance of the pump occurs at around 740Hz. Some modal interaction with this mode occurs during normal operation as seen in the steady state section of this report, but it is barely above noise level.
