Failure Analysis of a Primary Reactor Cooling Pump Using Modal and Vibration Analysis

Oak Ridge National Laboratory

Abstract

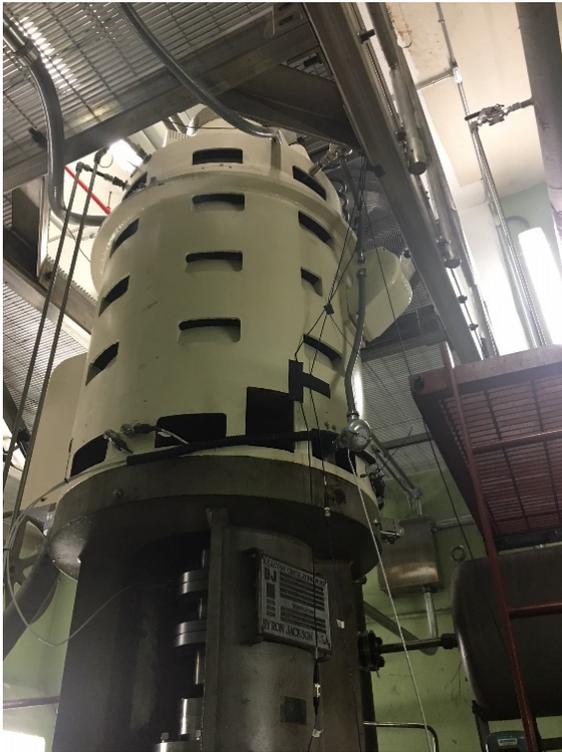
Figure 1 Motor and Flange

It was expected that an increased vibration would be noted at five times the rotational speed due to the pump's five vanes. The pump is positioned vertically in the following arrangement from top to bottom: pony motor, main motor, flange, pump housing. The motor and flange are depicted in Figure 1. Part of the pony motor can also be seen at the top of Figure 1. The pump assembly is anchored with four large bolts to an elevated steel platform. The flange, pump, and anchor bolts are depicted in Figure 2.
